**Area in Need of Redevelopment Investigation for Block 8409, Lots 1 & 26  
in the Township Of Morris, New Jersey**

PHILLIPS PREISS GRYGIEL LEHENY HUGHES LLC | Planning & Real Estate Consultants | September 2018

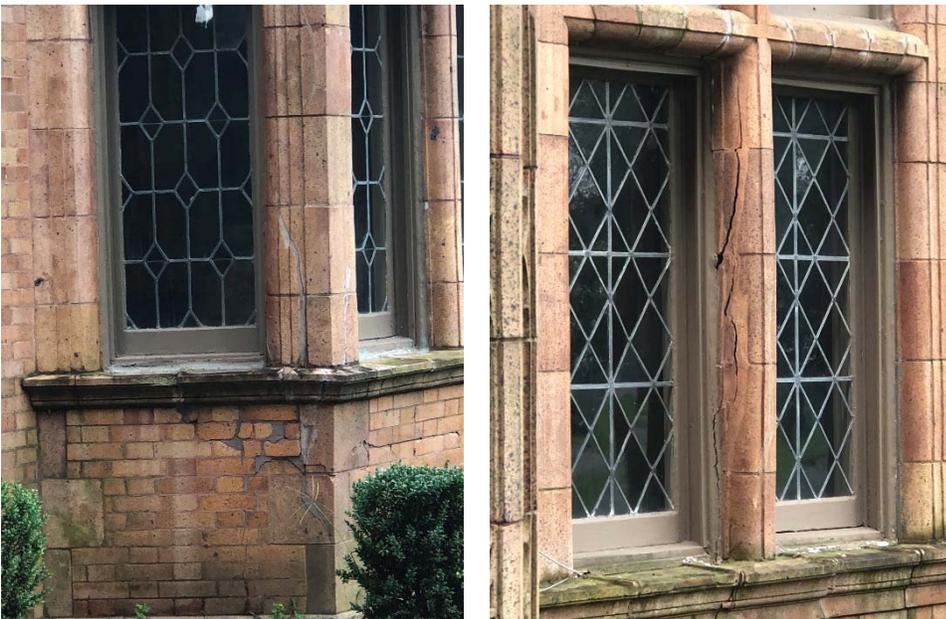
**The facades of the building consist of a combination of brick and terra cotta. There is evidence of damaged and cracked brick and water damaged terra cotta (left photo) and staining and vegetation (right photo).**

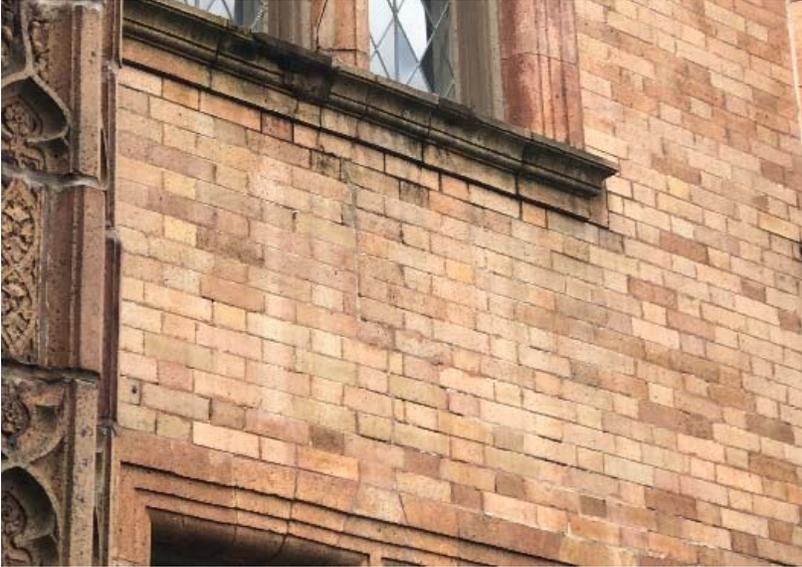
**Evidence of water damage to terra cotta window sills and missing mortar requiring repointing.**

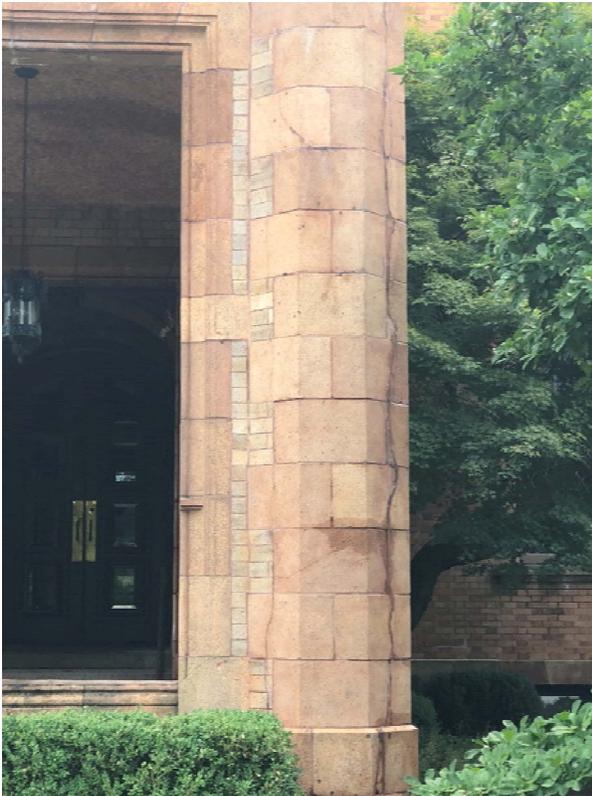
**Evidence of water damage to terra cotta decoration.**

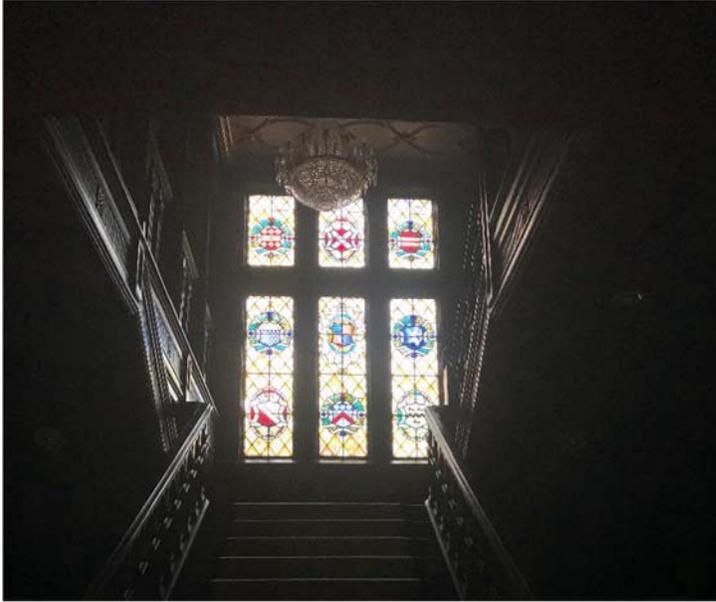
Central stair which connects all three levels. There are no fire barriers surrounding it, nor are fire sprinklers or a smoke purge system provided. The existence of an unenclosed, unprotected three story atrium with the main egress stair running through it does not comply with current building code. The railing is loose at the top run of the stair and cannot support the requisite lateral load.

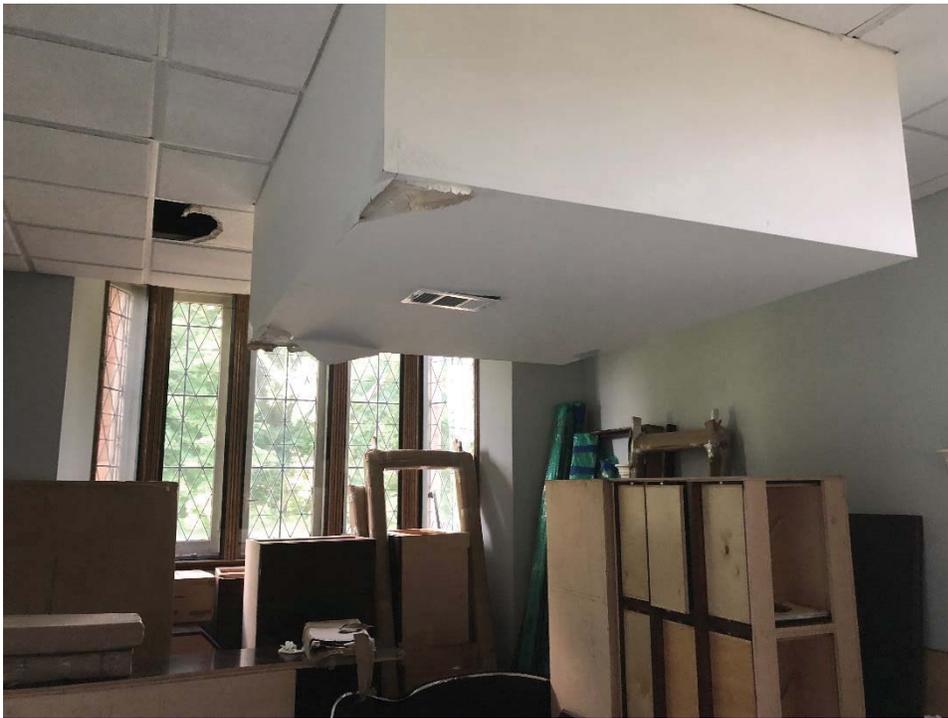
**The southwest wing of the ground floor has a dropped ceiling with acoustic tile and fluorescent light fixtures. There is evidence of water damage to the ceiling and missing or torn acoustic tiles.**

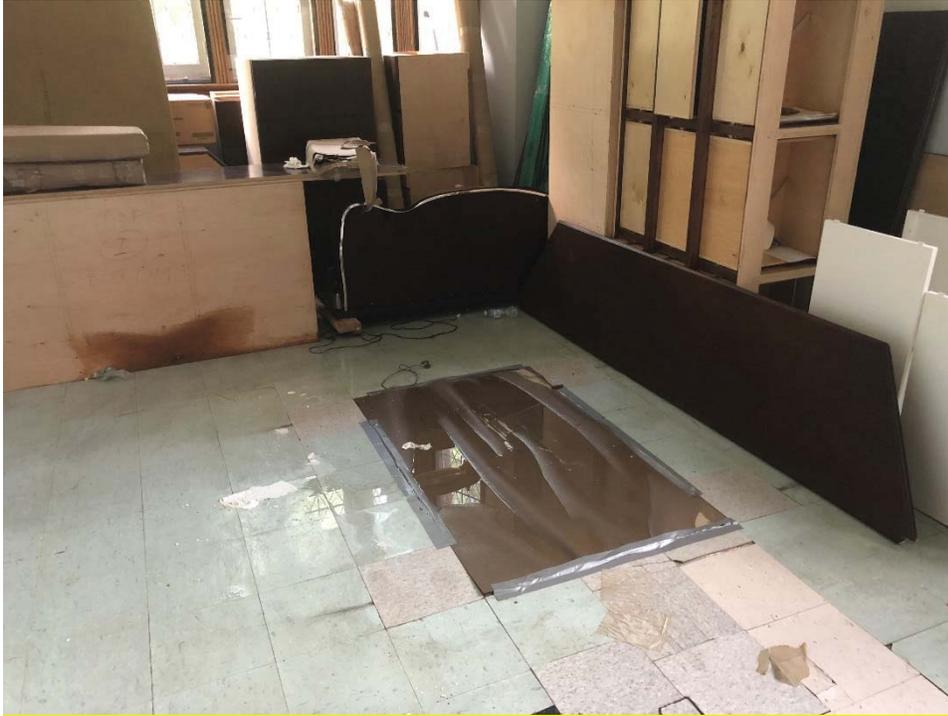
**Evidence of water damage in the southwest wing.**

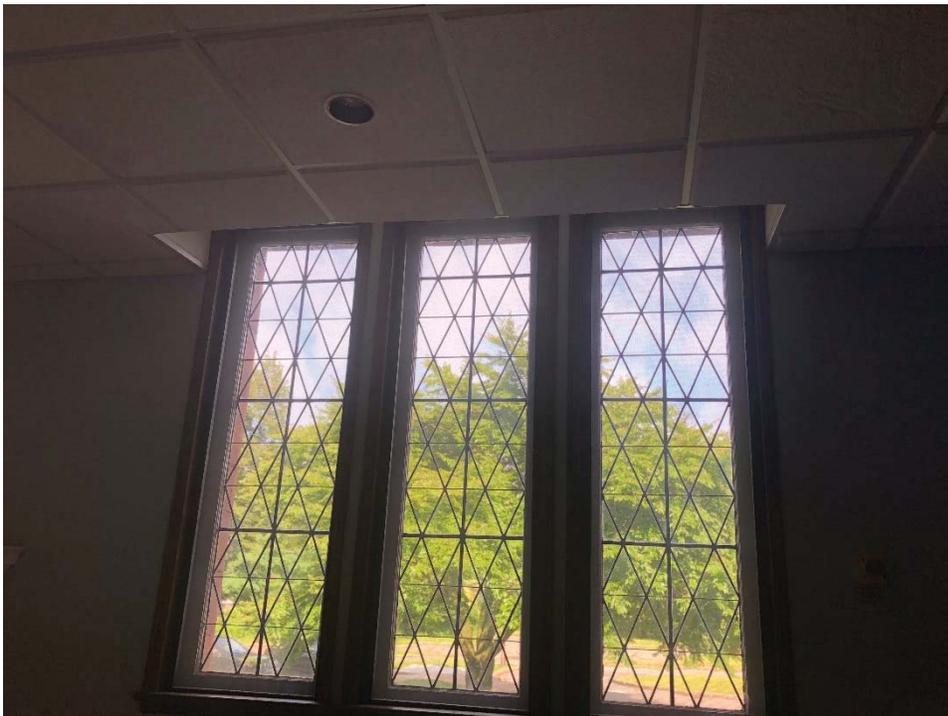
**Dropped ceiling cuts off top of window frame in the southwestern wing.**

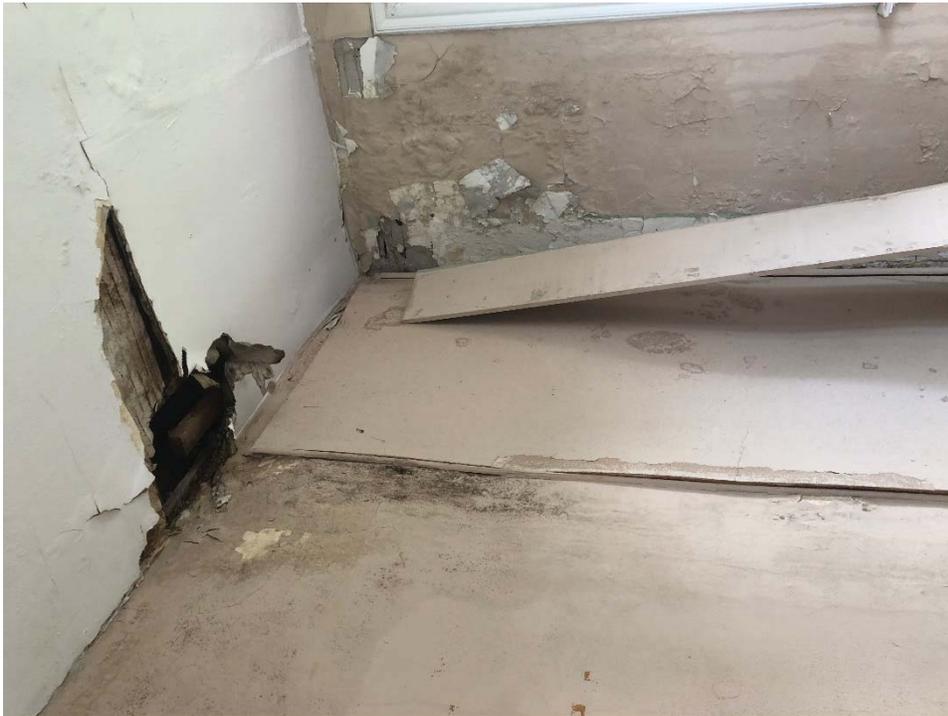
**Water damage in the southwestern wing.**

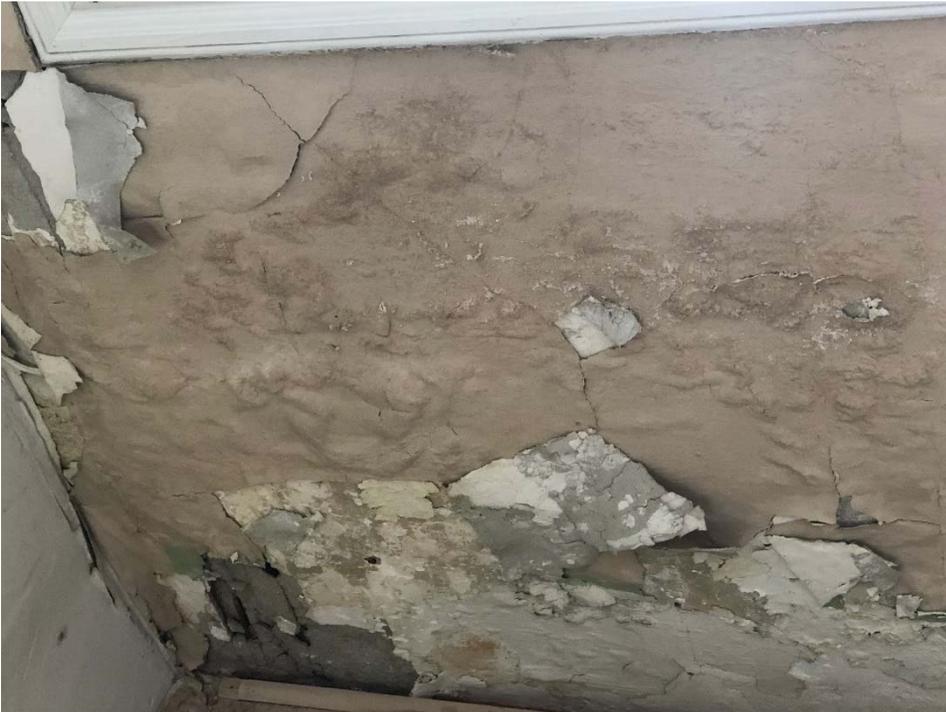
**Water damage in the southwestern wing.**

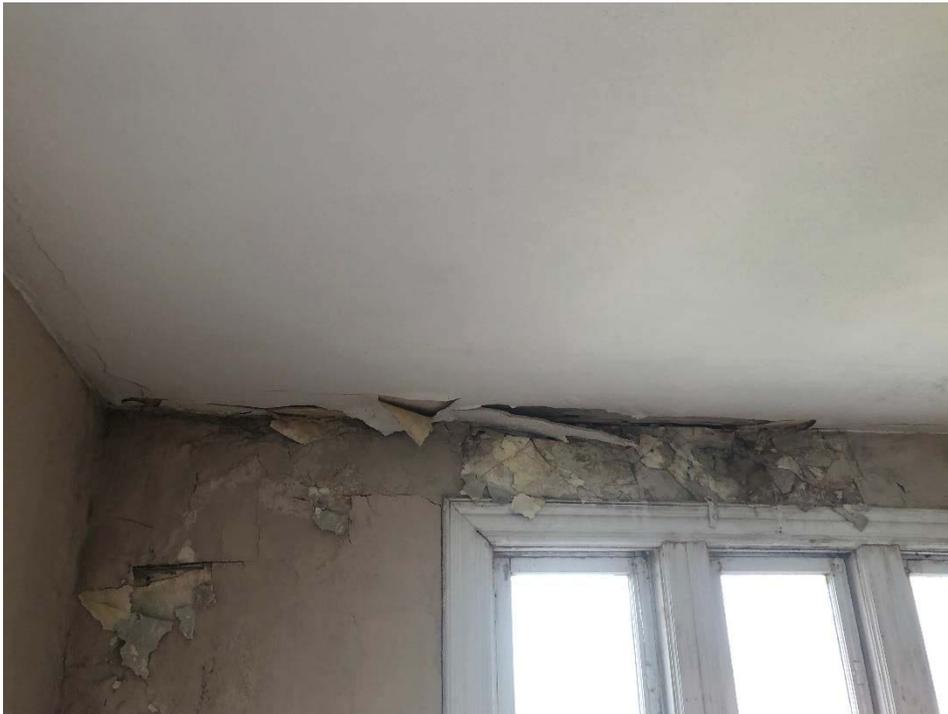
**Water damage in the southwestern wing.**

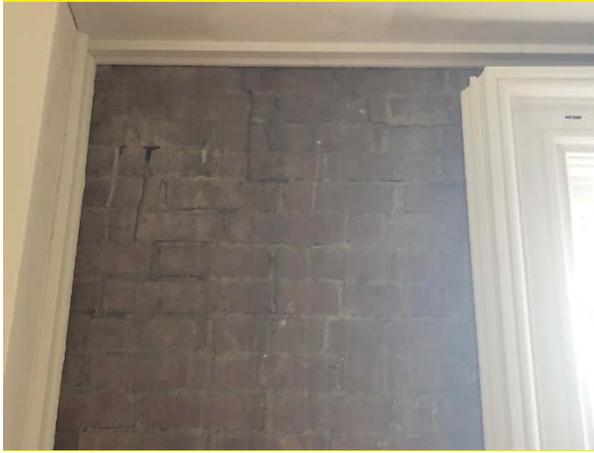
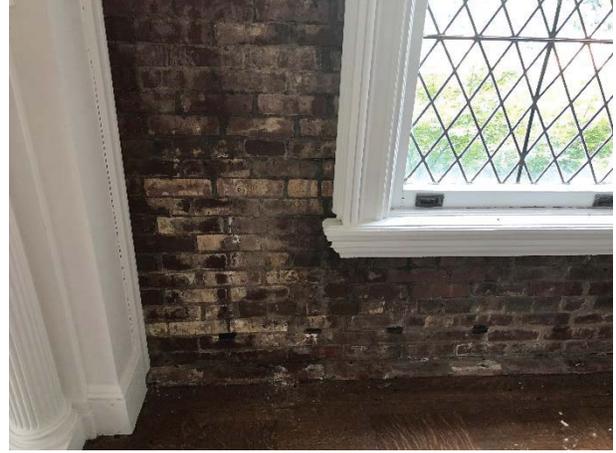
**Water damaged brick in second floor interior resulting in degraded mortar joints.**

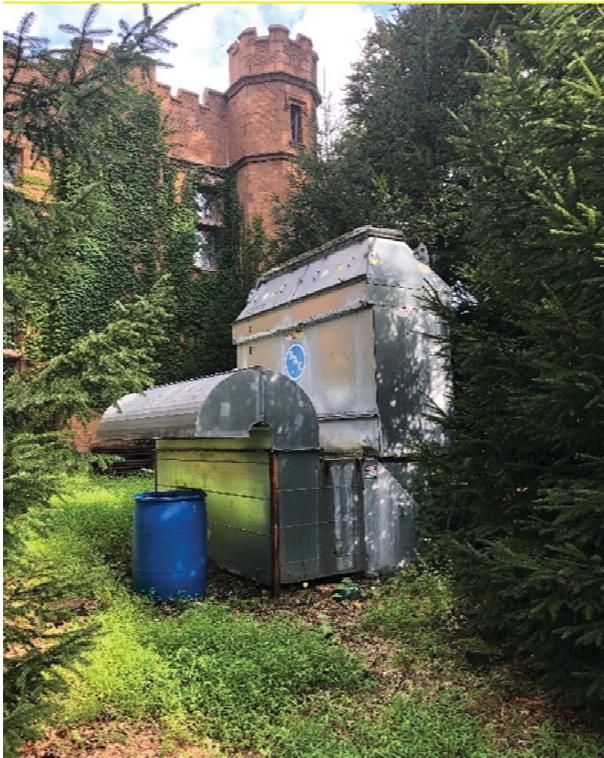
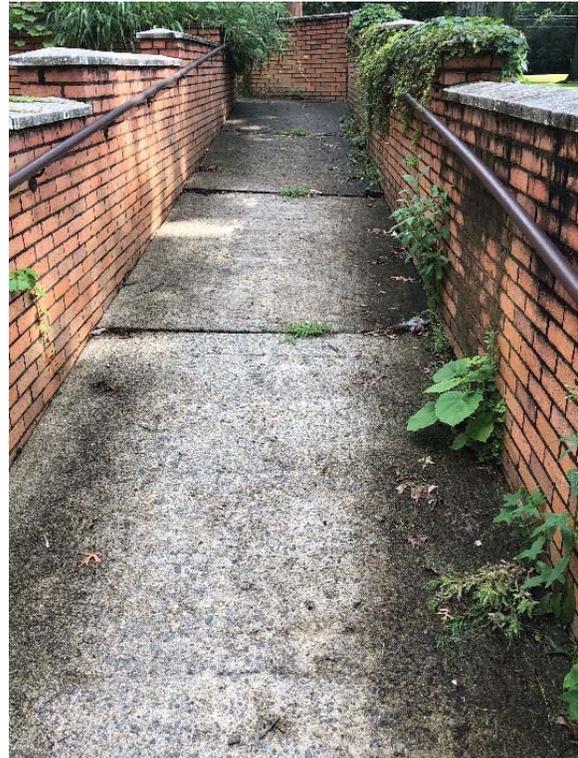
**(Left) is 35 ton Baltimore Air Coil (BAC) Chiller estimated to be 50 years old. (Right) There is no barrier free access to the building or to the multiple levels within the building. The existing ramp has settlement and the cross slope of the ramp exceeds the allowable cross slop of 1 in 48.**

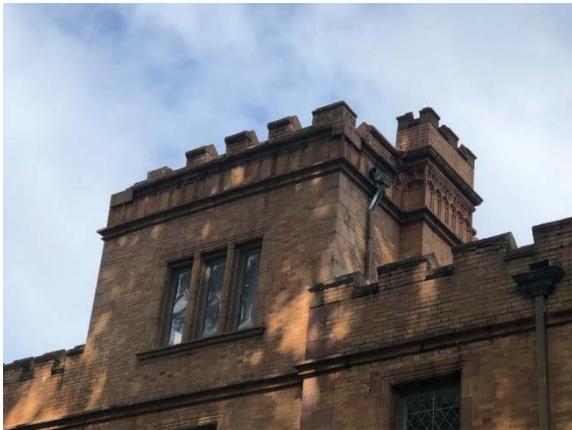
**There is significant deterioration on the parapet at a number of locations.**

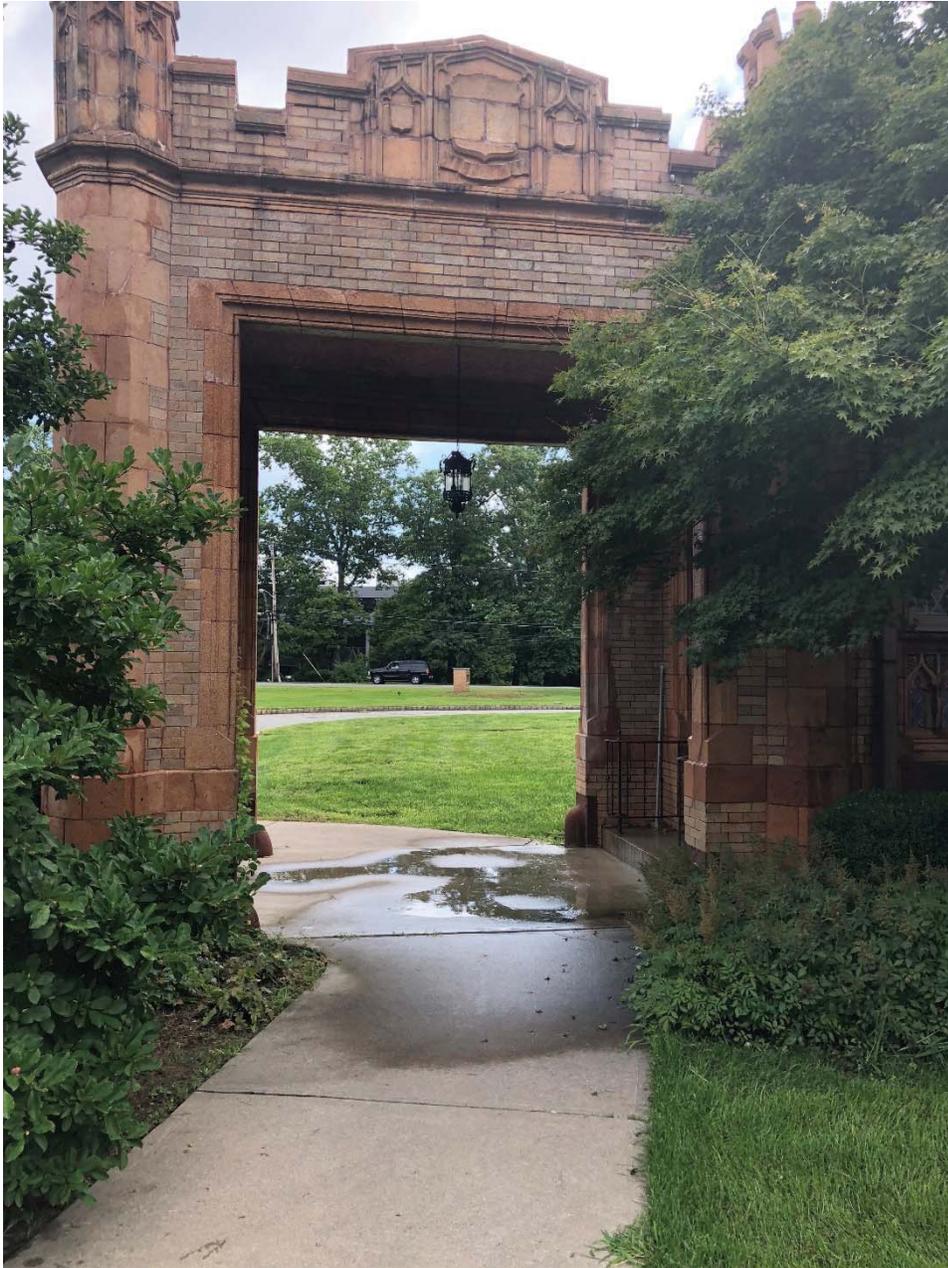
**Water leaking through roof or porte cachere.**

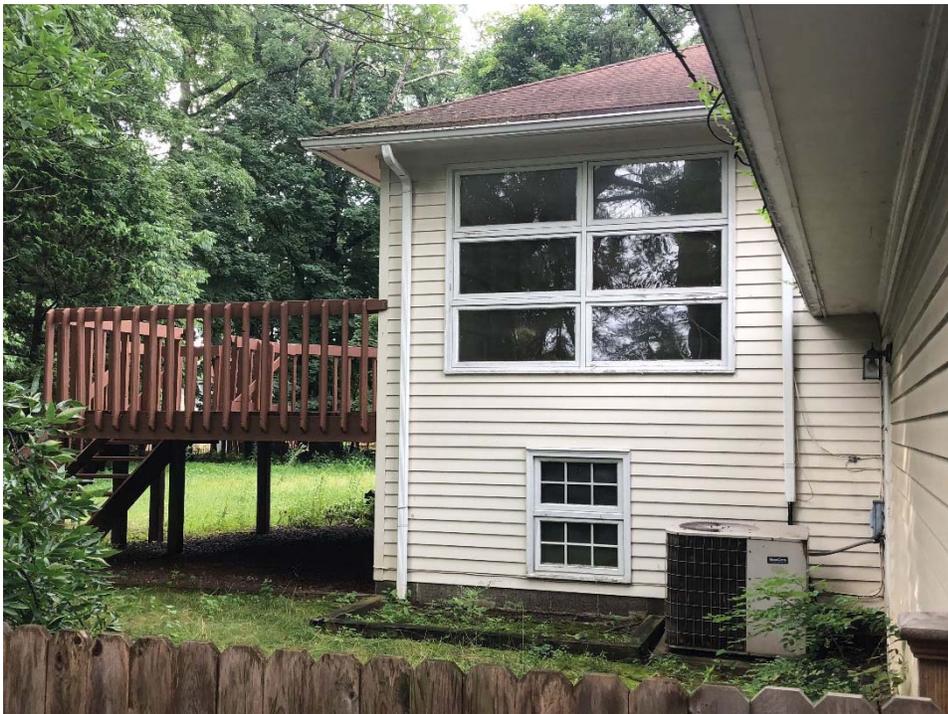
According to the Building Inspection report for this property there are a number of issues that require action prior to its reuse for residential purposes. For example, the rear wood deck has several boards that have wood rot along the edges; there are several joist hangers that are rusted; and there is excessive mold under the decks. None of the exterior outlets have ground fault protection. The roof is in the primary stages of decomposition and near the end of its serviceable life. A site visit showed the roof has excessive moss on the shingles which will accelerate its deterioration. The gutters are also clogged with vegetation. The air vent on the boiler is corroded. Additionally, there are loose bricks at the top of the chimney and the chimney crown (designed to seal the chimney wall and shed rainwater) is cracked and should be sealed.

**Rear section of Lot 26 showing wood deck which connects with upper level of the split-level home. The deck shows signs of structural and material deterioration.**

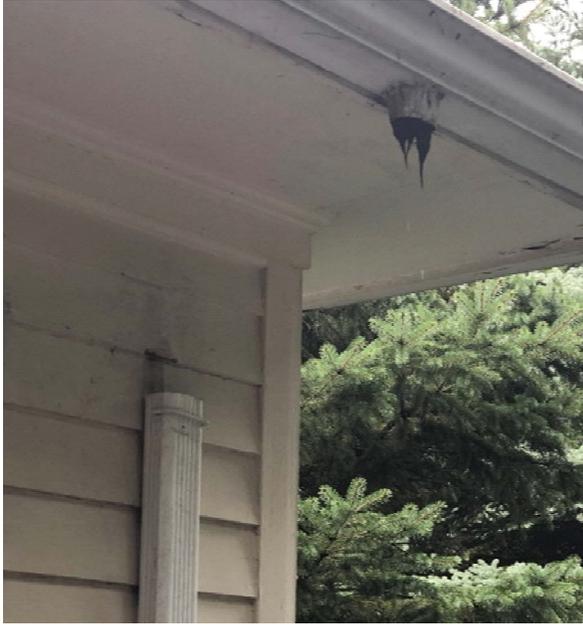
**Broken downspout by garage.**

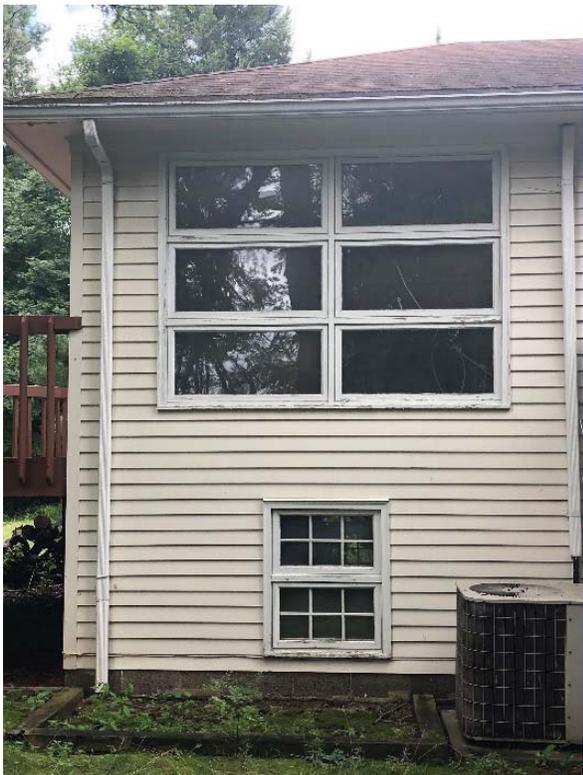
**Windows are deteriorating. The lower story window came loose from the façade during a site visit. The windows in the upper story living room are sealed shut.**

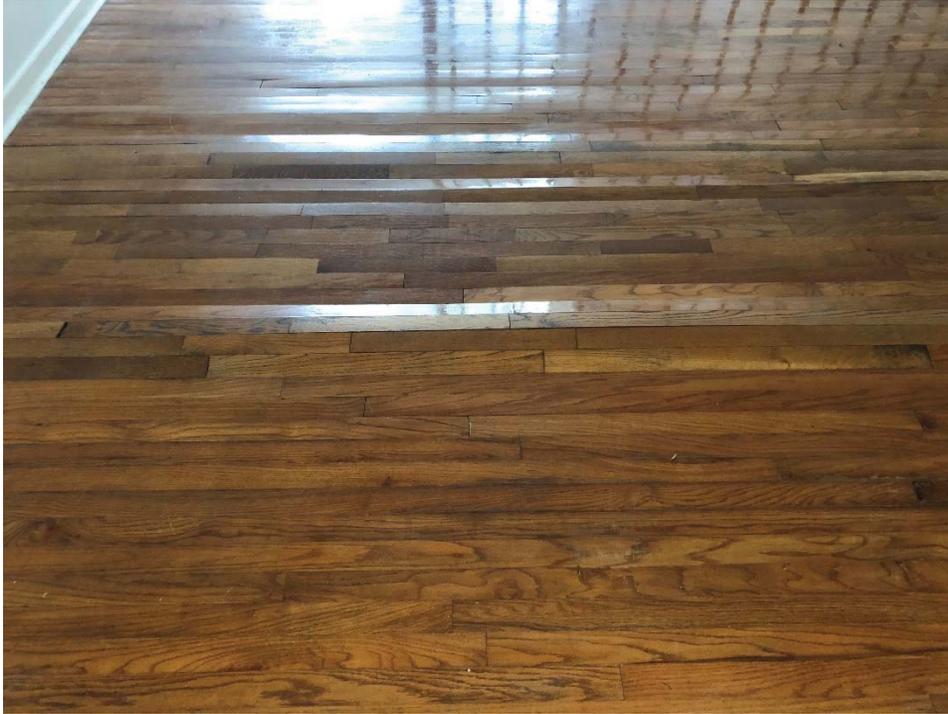
**Buckling in the dining area of the upper floor.**

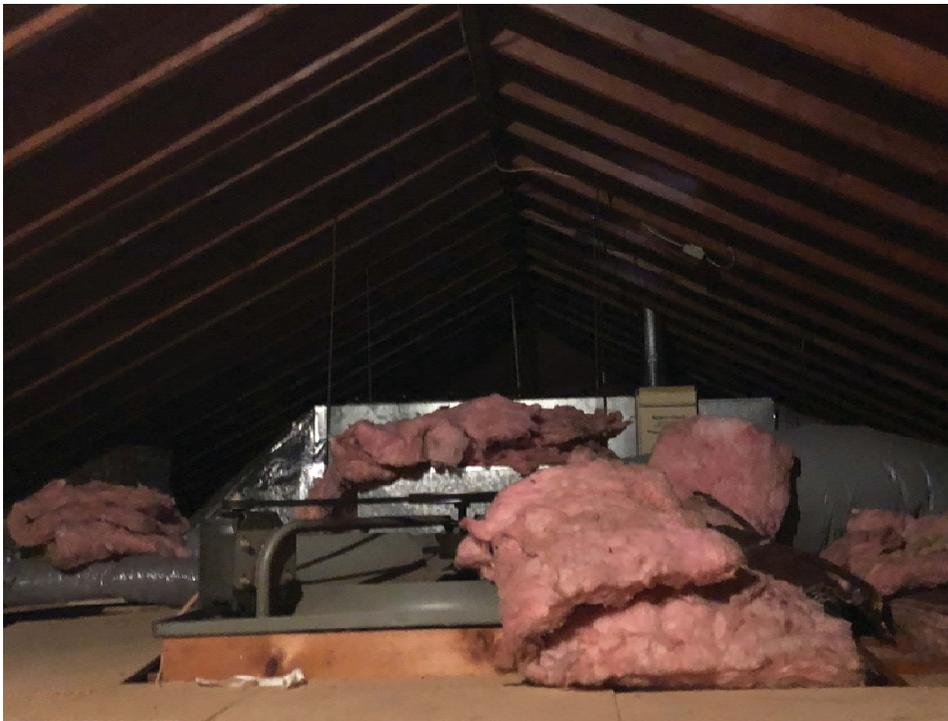
**There are live electrical wires in the attic.**

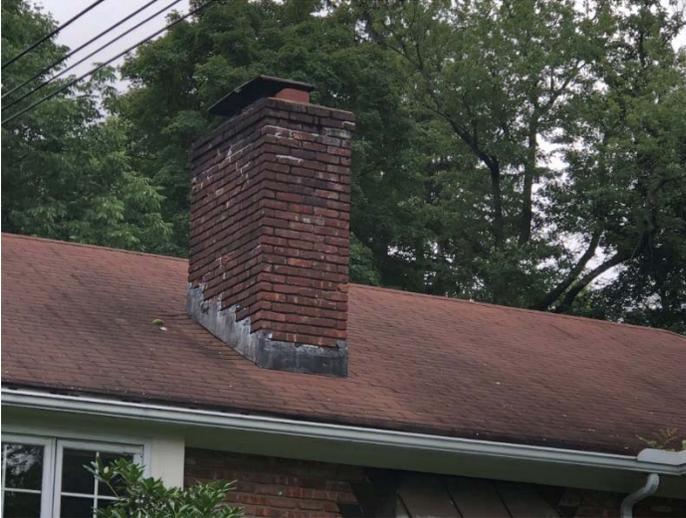
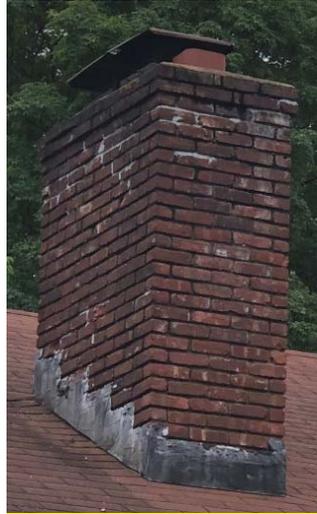
**According to a building inspection report for the home there are loose bricks at the top of the chimney and the crown, which is designed to seal the chimney wall and shed rainwater, is cracked and needs to be sealed.**

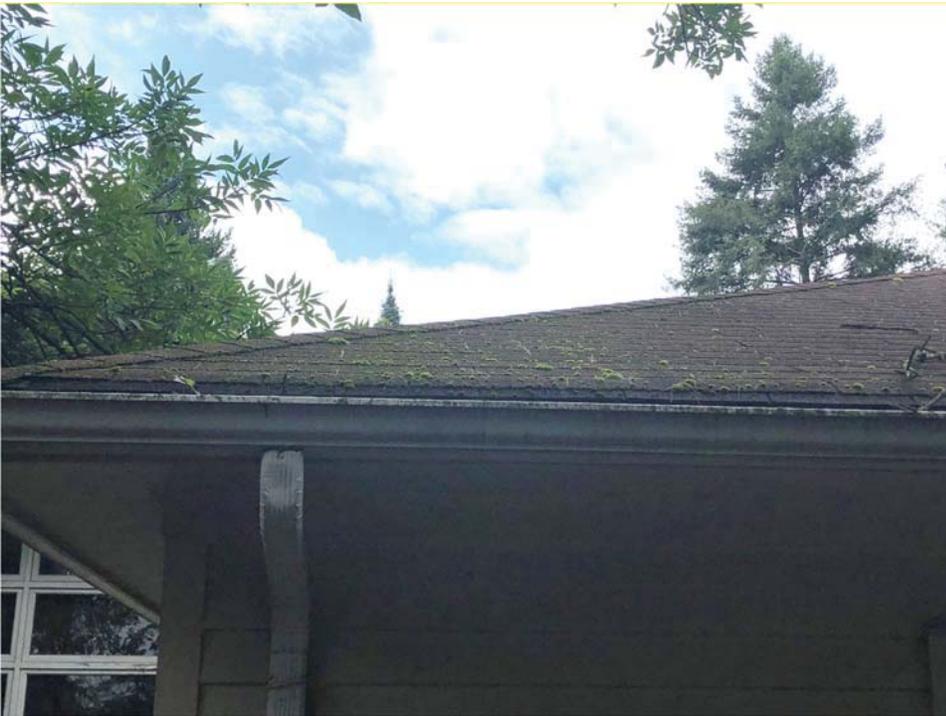
**The roof has excessive moss on the shingles which will accelerate the deterioration of the roof.**

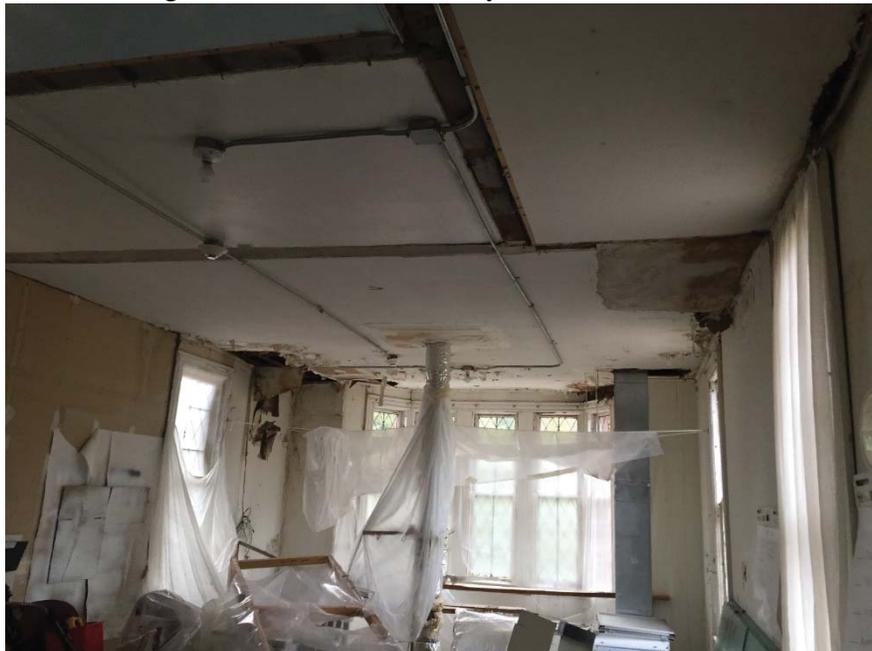
*Water Infiltration at Southeast Wing*

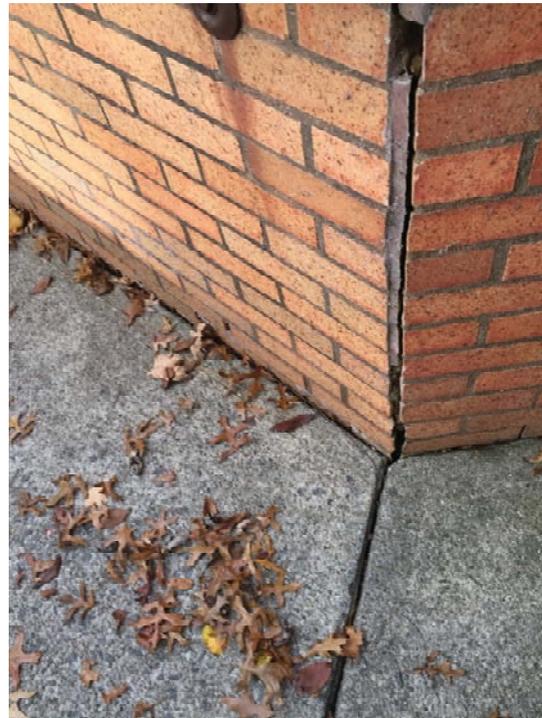
*Damaged Screen Wall and  
Non-compliant Barrier Free Access Ramp*

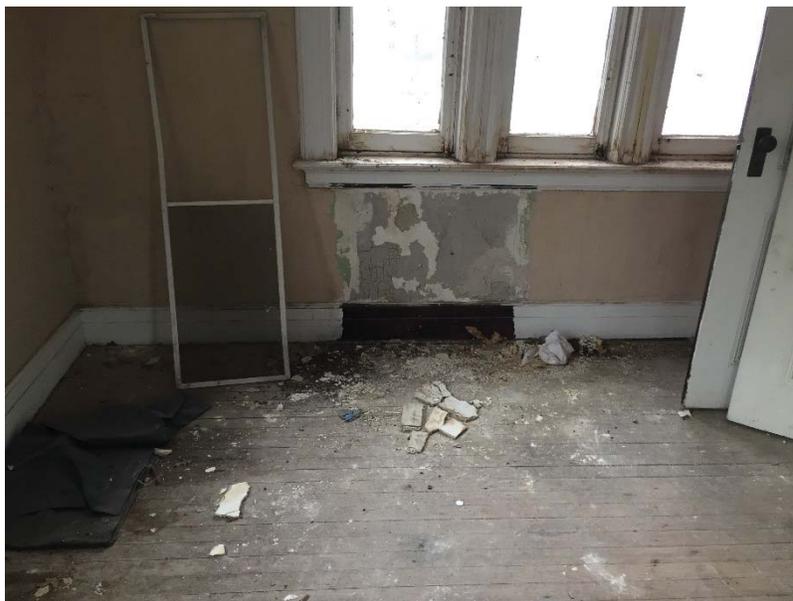
*Water Damage at Loft Area*

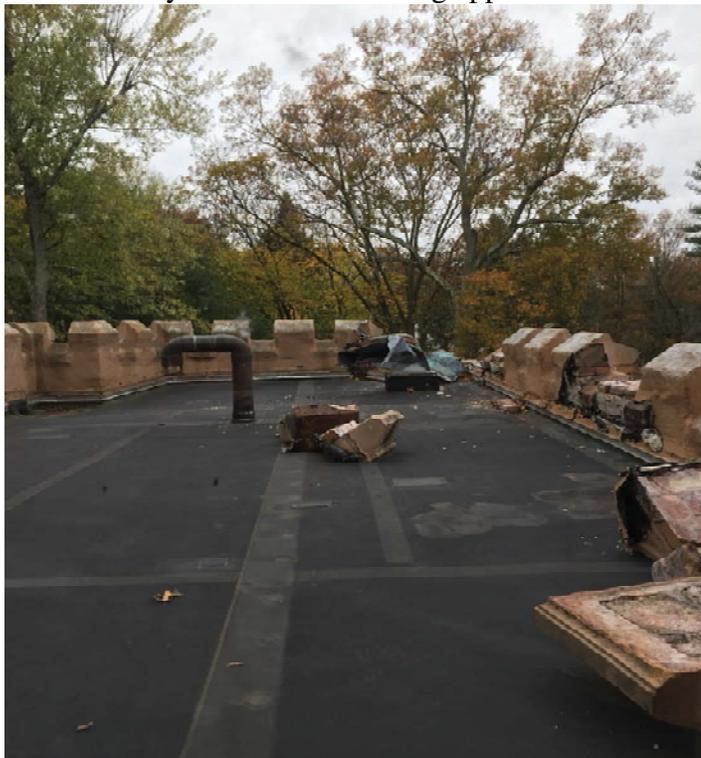
*Damaged Machicolation*

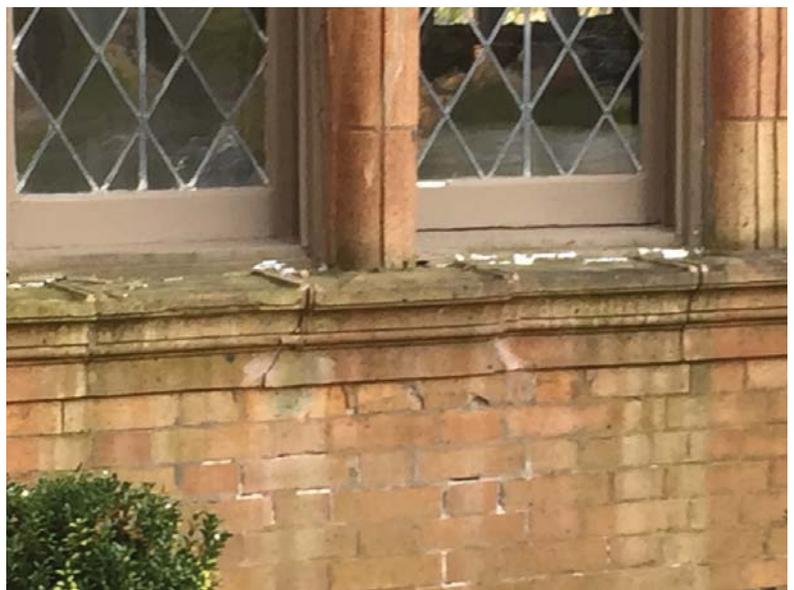
*Damaged Stone Sill and Failed Mortar Joints*

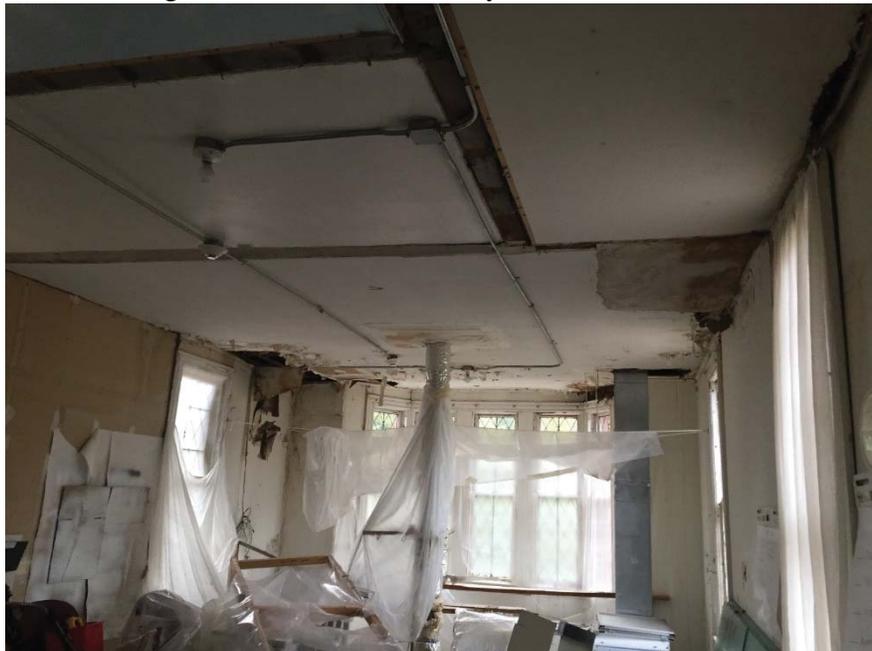
*Water Infiltration at Southeast Wing*

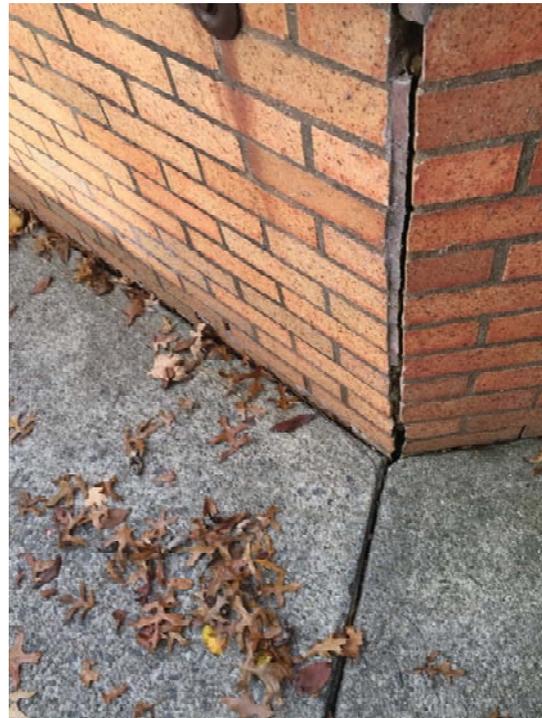
*Damaged Screen Wall and Non-compliant Barrier Free Access Ramp*

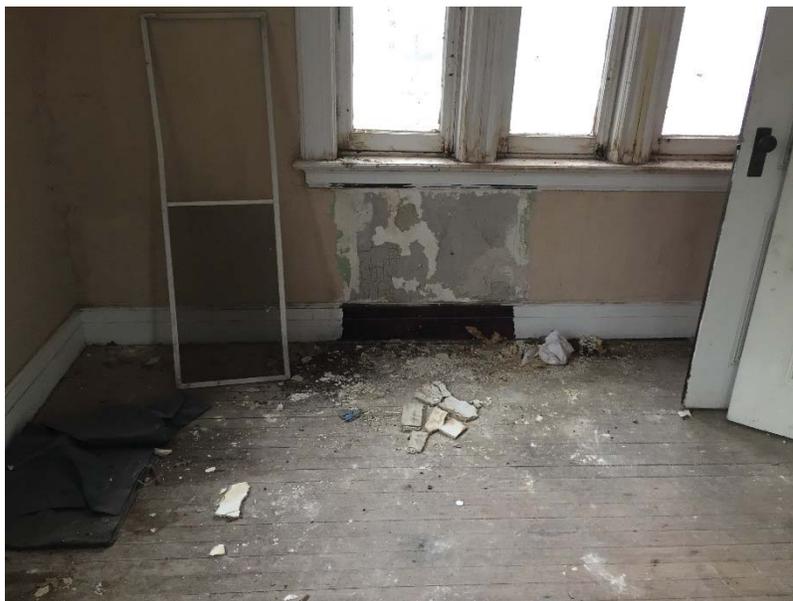
*Water Damage at Loft Area*

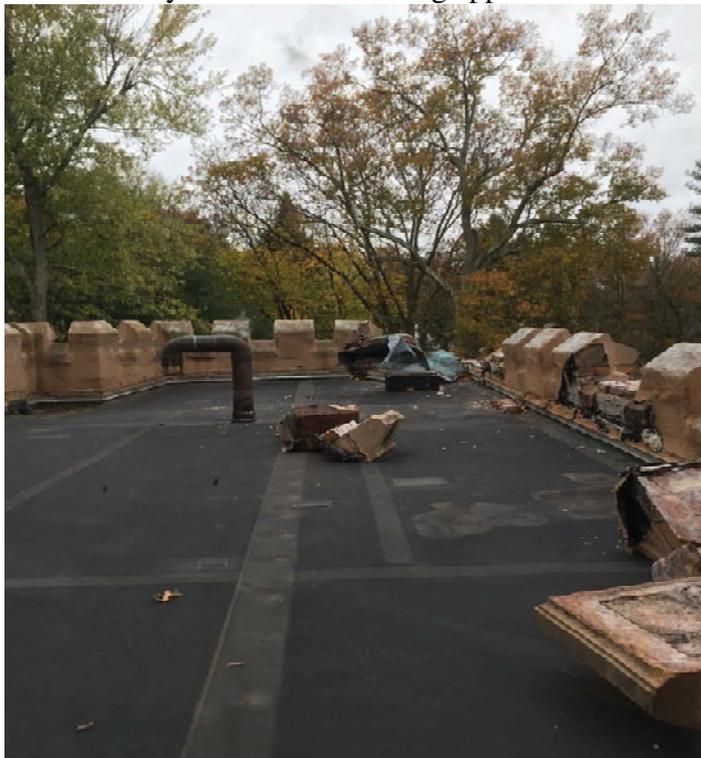
*Damaged Machicolation*

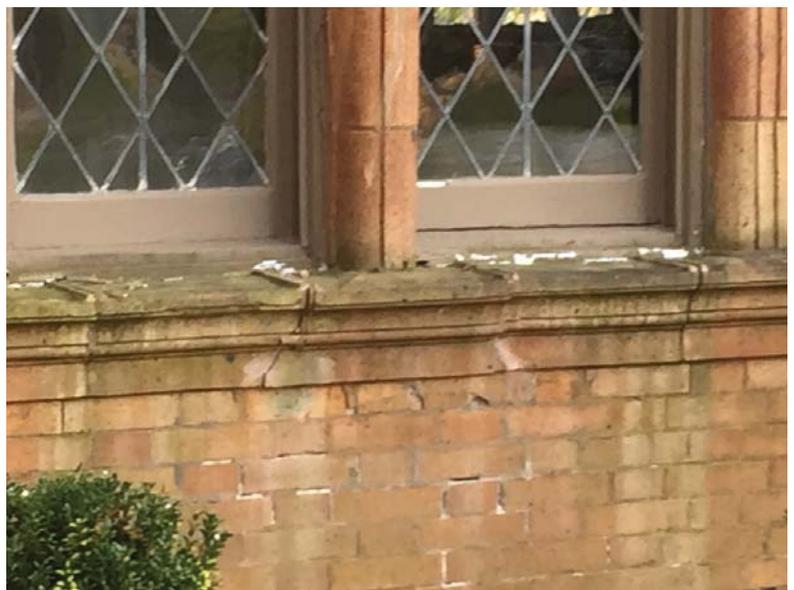
*Damaged Stone Sill and Failed Mortar Joints*

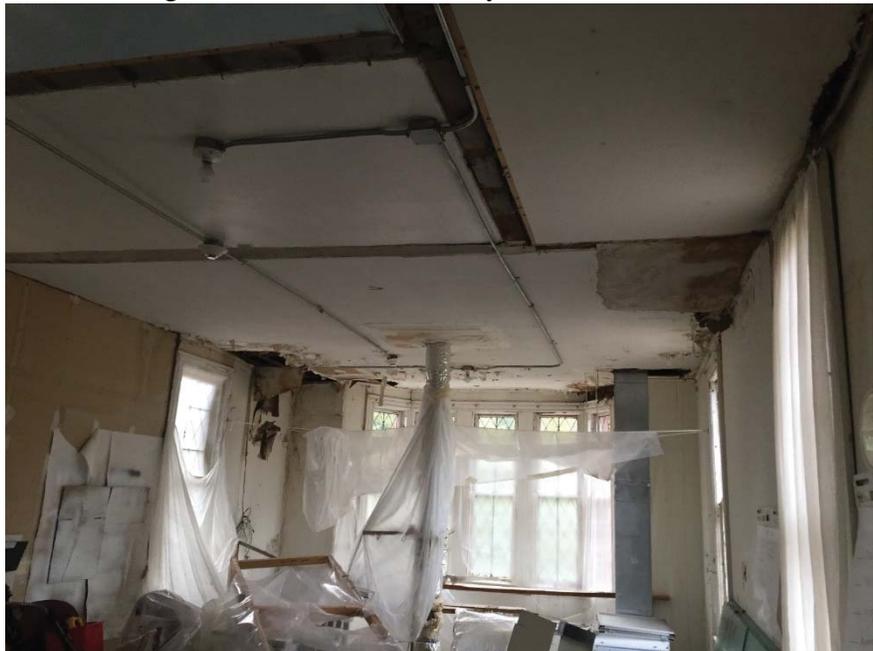
*Water Infiltration at Southeast Wing*

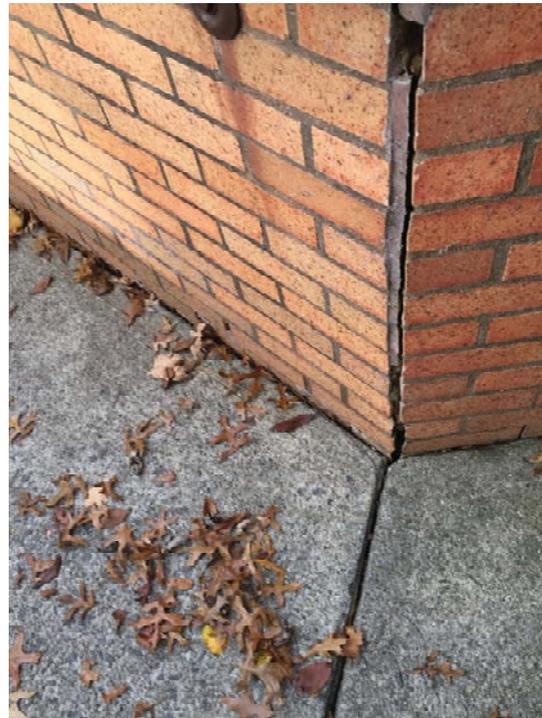
*Damaged Screen Wall and Non-compliant Barrier Free Access Ramp*

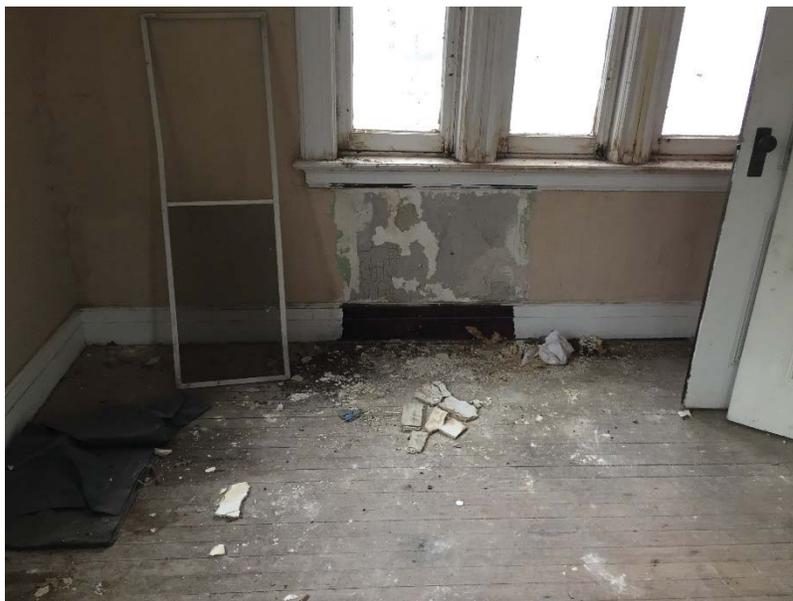
*Water Damage at Loft Area*

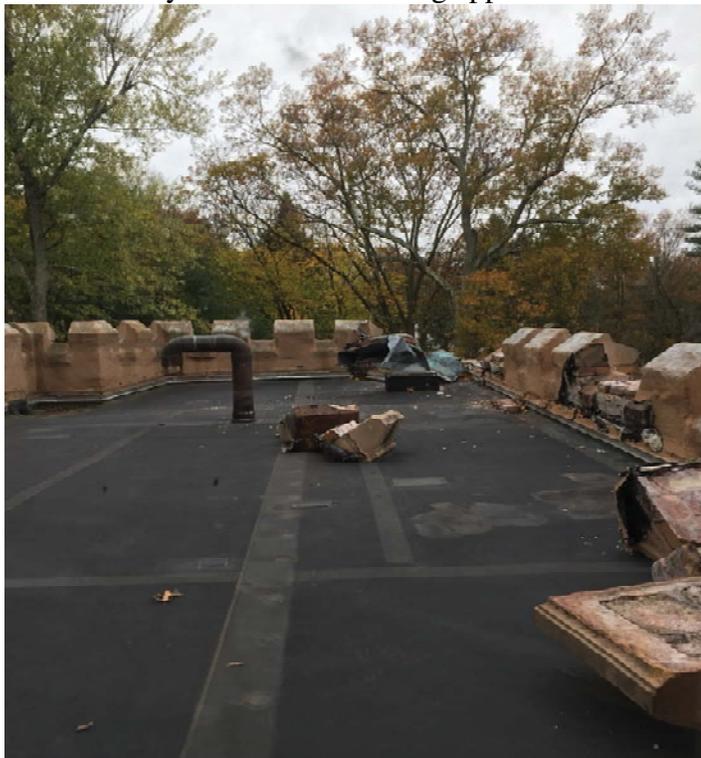
*Damaged Machicolation*

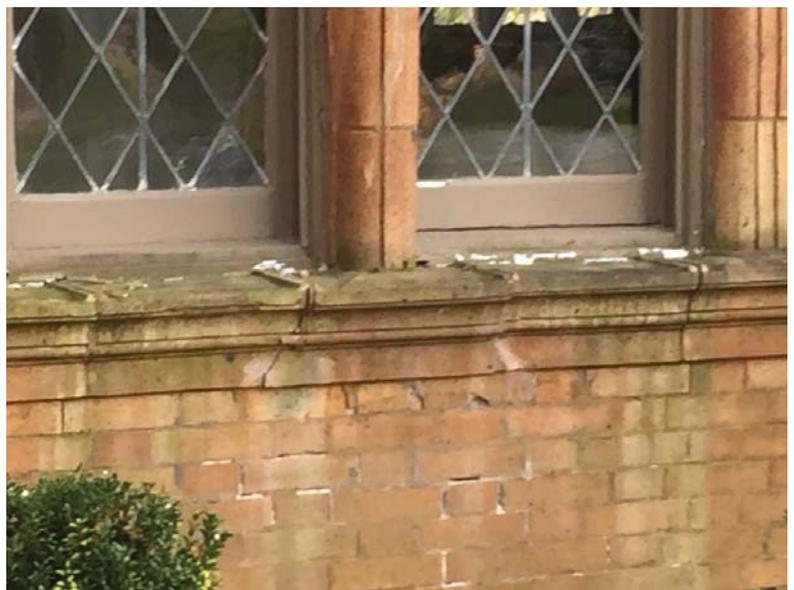
*Damaged Stone Sill and Failed Mortar Joints*
