**Area in Need of Redevelopment Investigation for Block 8409, Lots 1 & 26  
in the Township Of Morris, New Jersey**

PHILLIPS PREISS GRYGIEL LEHENY HUGHES LLC | Planning & Real Estate Consultants | September 2018

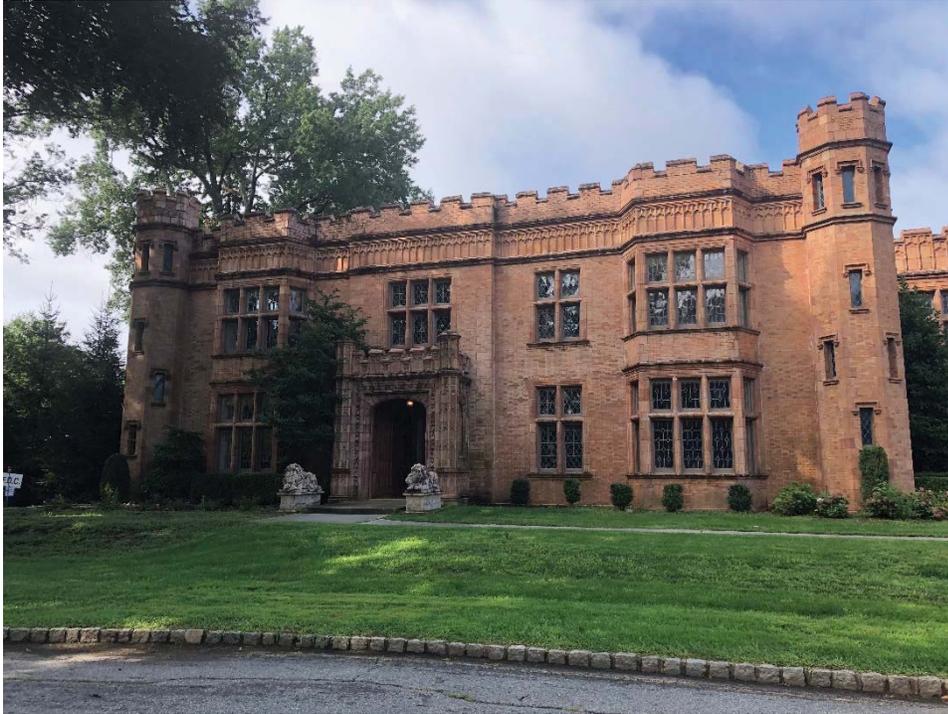
**Front façade of The Abbey (Block 8409, Lot 1) facing northeast toward Madison Avenue. The building comprises two floors and a finished basement. There is no attic. The building height from ground to parapet is approximately 33 feet. The rectangular main block of the house measures approximately ±80 feet X ±95 feet**

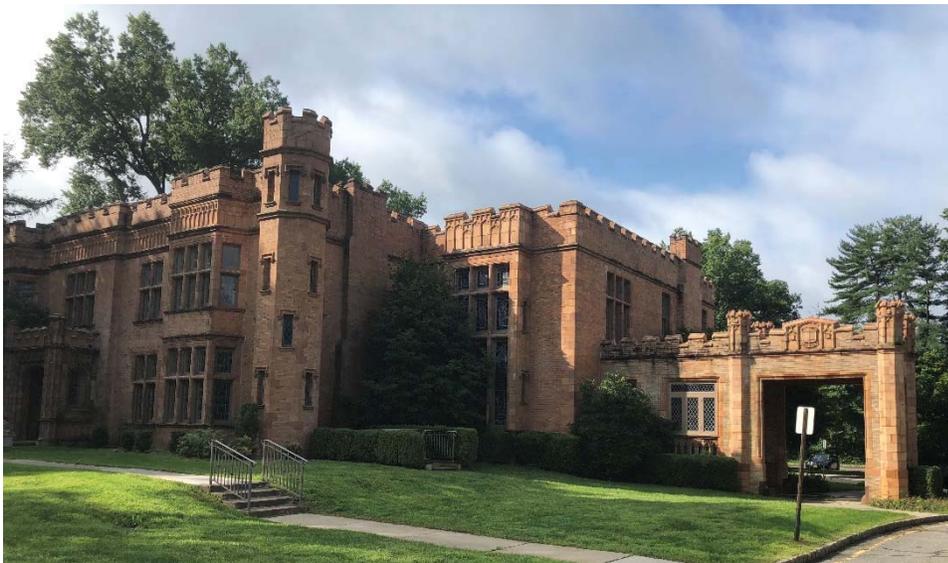
**A porte cochere extends 32' from the northwest facade.**

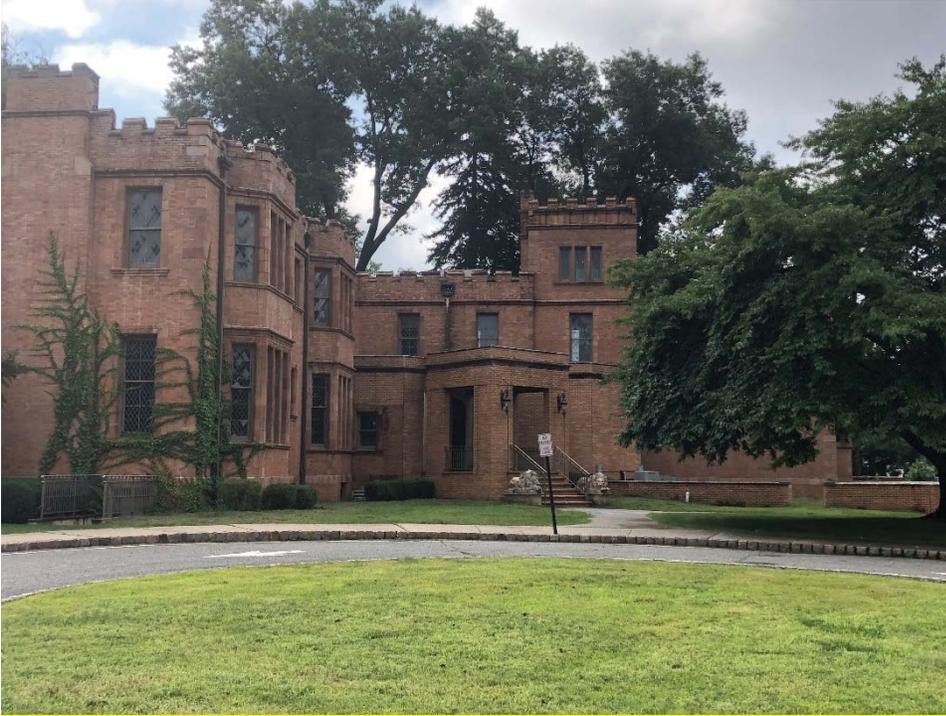
**The rear façade facing southwest. The regular outline of the house is broken by semi-octagonal bays and towers. The roof is flat and surrounded by a masonry castellated parapet.**

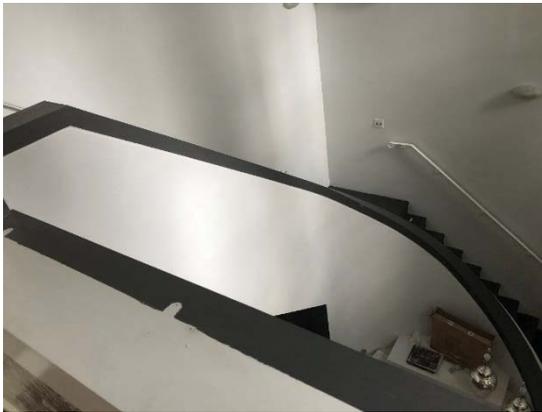
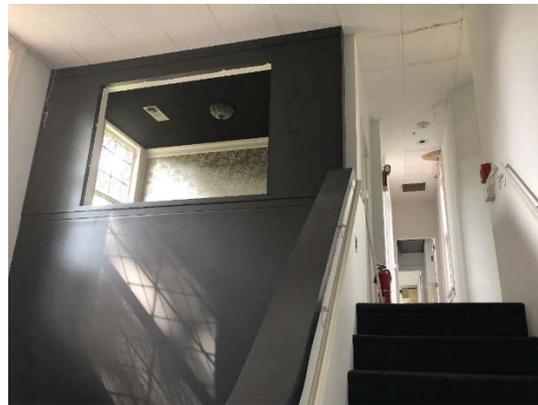
Modern second stair immediately adjacent to the central staircase serves the second floor. It is circular and has an atrium. The atrium is open to both floors without any fire protection or separation. Due to the close proximity of the stairwells to one another, the 2<sup>nd</sup> floor is not considered to be served by two means of egress. Egress stairs cannot be located in open atriums unless protected by fire sprinklers, separated by fire barriers, and have adequate smoke purge systems.

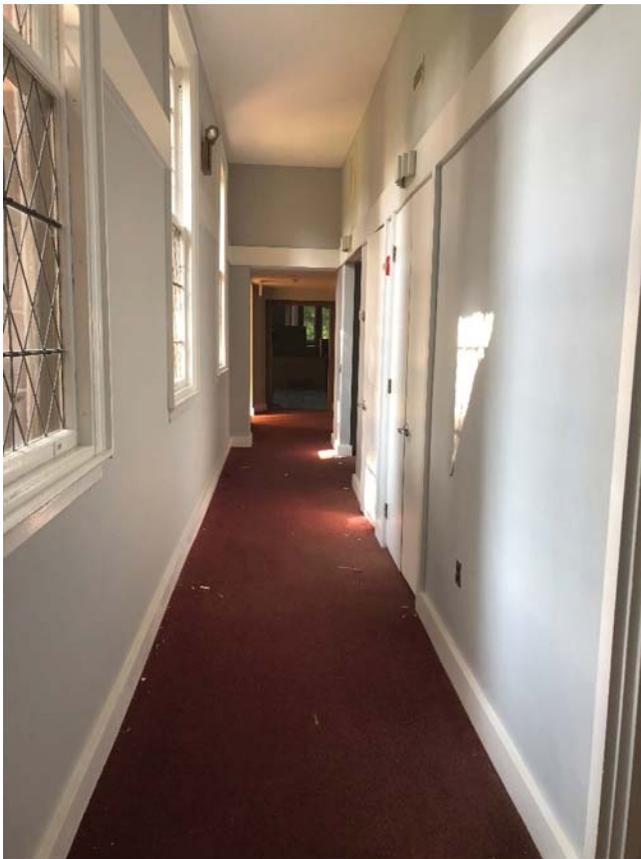
**The southwest wing which was modernized for office space including an X-Ray room.**

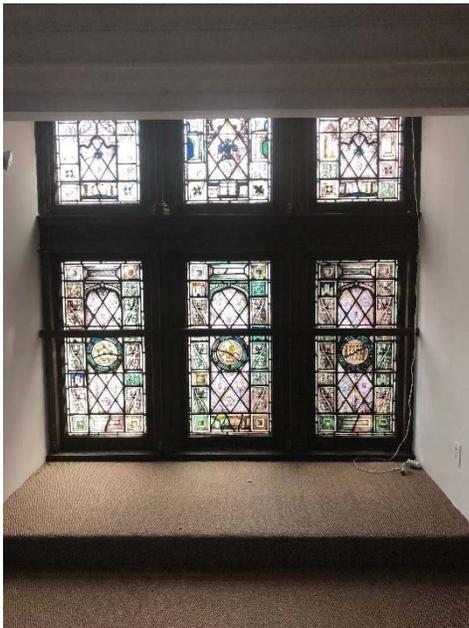
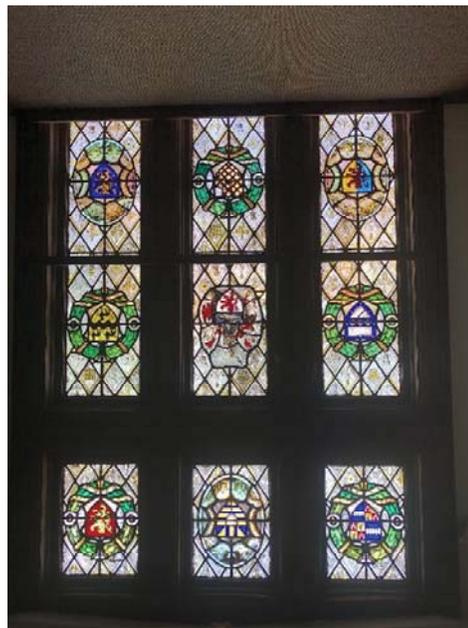
**A mezzanine structure was added above the former grand ballroom. It has limited ceiling height which is not proportional to the existing historic windows.**

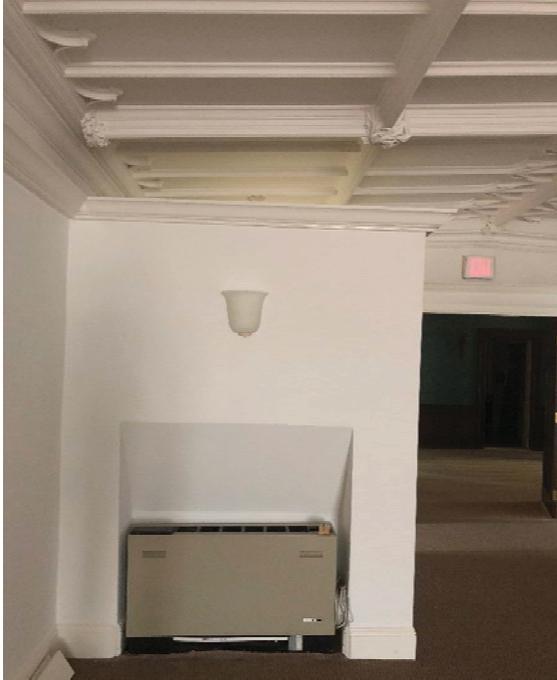
**Modern wall sconce in mezzanine area above former grand ballroom.**

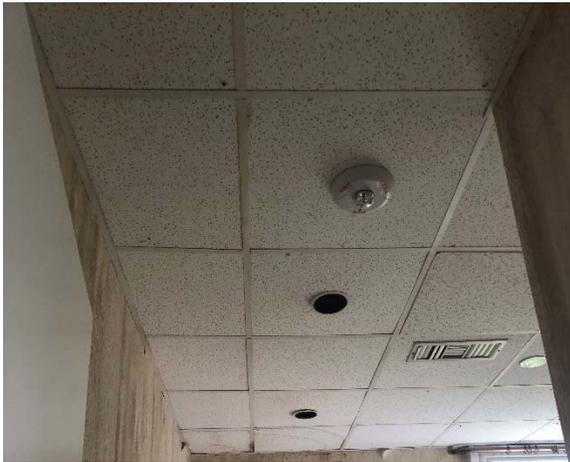
**Recessed modern lighting in southwestern wing.**

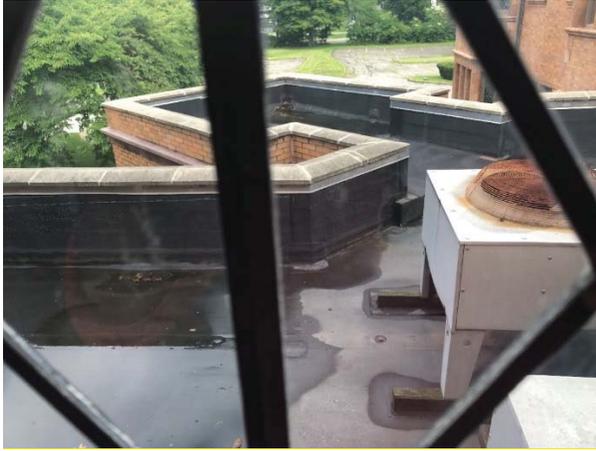
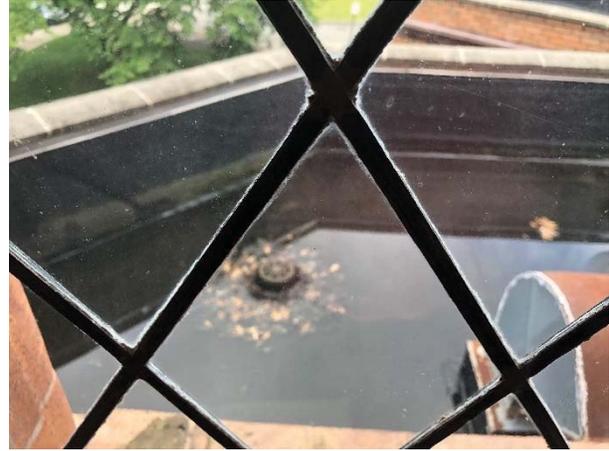
There is evidence of significant water infiltration at the southwestern wing of the building. A site visit revealed water leaking through the roof to the second level and water damage on the first and second levels in the southwestern wing. According to the Building Evaluation report, there are also concerns about the age of the HVAC system (estimated to be 50 years old) and destructive investigation may be required to ascertain conditions and/or perform the necessary maintenance. Additionally, due to the age of the chiller and boiler plants there are concerns about the lack of energy efficiency. Only the basement level is protected by a fire sprinkler system due to it being a windowless story. There is no sprinkler system for the first and second floor levels. The Building Evaluation report recommends that, if the building were to be reused, all levels of the building should be sprinklered. The Building Evaluation report further notes that none of the light fixtures appears to be high efficiency type fixtures.

**Water collecting on roof in southwestern wing.**

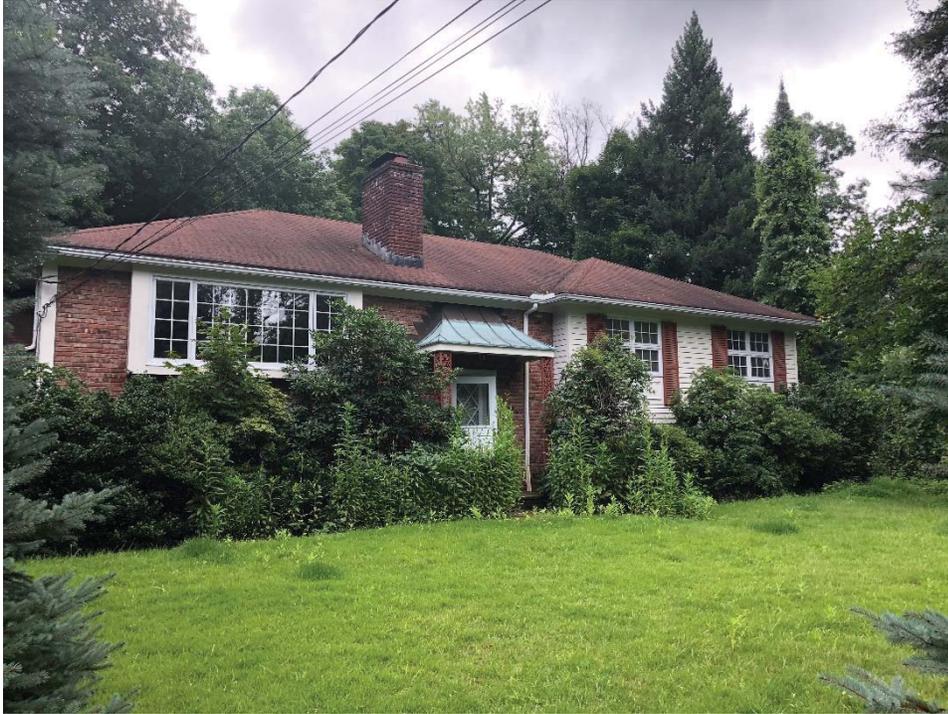
**Front façade of 73 Canfield Road (Block 8409, Lot 26) west.**

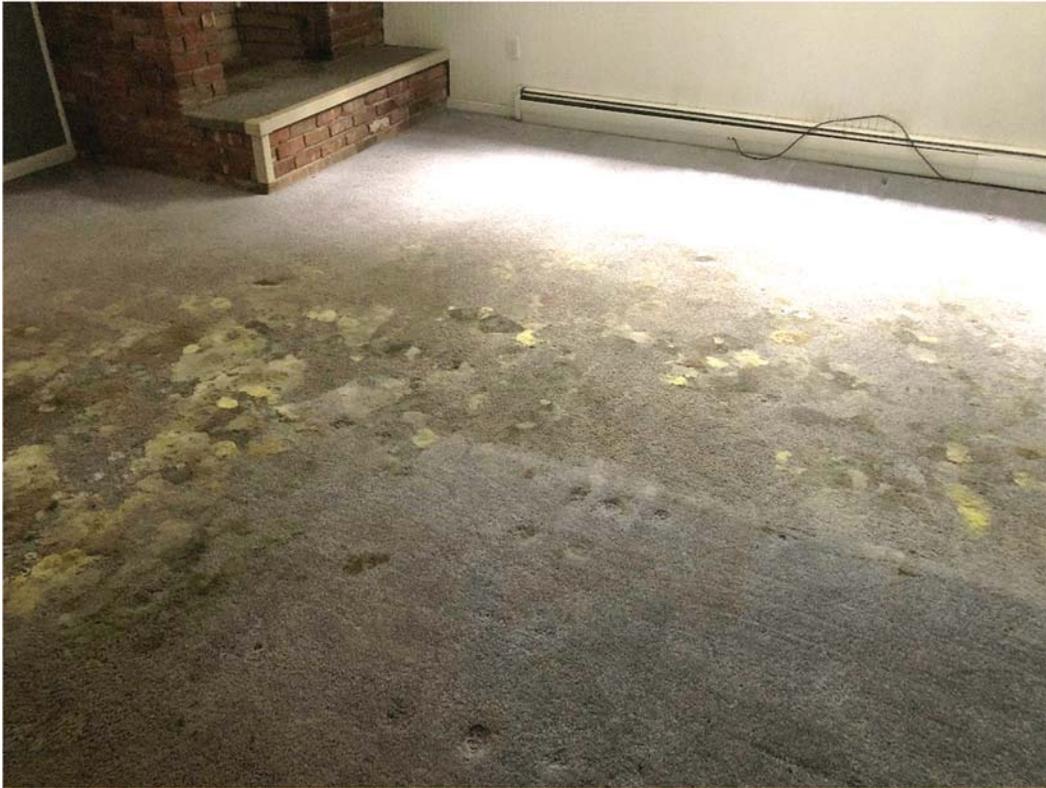
**Mold on the carpet of the lower level living area.**

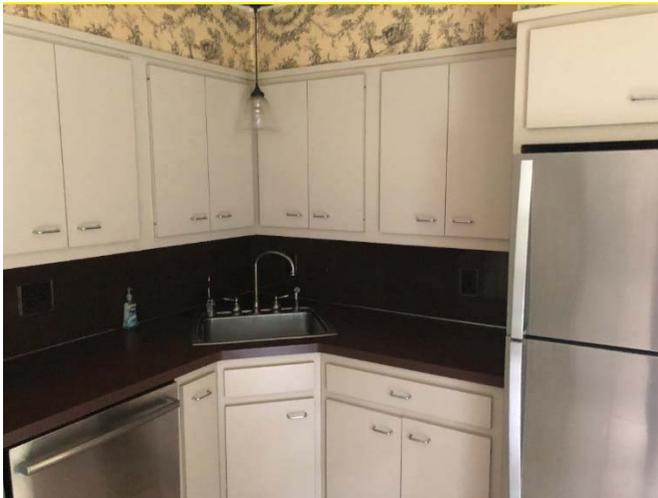
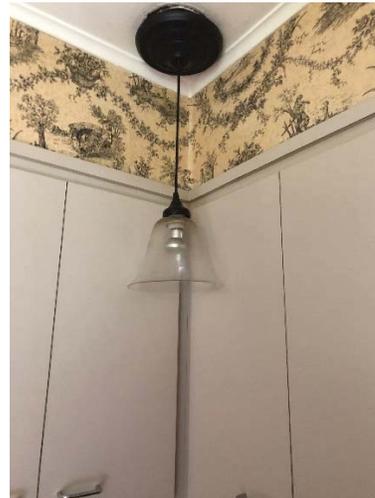
The windows in the living room are stuck or painted shut. The shower valves in the master bathroom leak while in use. The master bathroom outlets do not have ground-fault protection nor do the bathrooms in the second floor hallway. The cabinet doors cannot be opened without hitting the glass light. The attic ventilator fan did not function at the time of inspection. There is moisture damage in the garage (i.e., to the drywall in the back right corner near the electrical panels) and the outlets do not have ground fault protection. The site visit further revealed the presence of mold throughout the building, as well as floor buckling in the upper level dining area.

**A kitchen light in the corner of the upper story kitchen cabinets. The cabinet doors cannot be opened without hitting the glass light.**

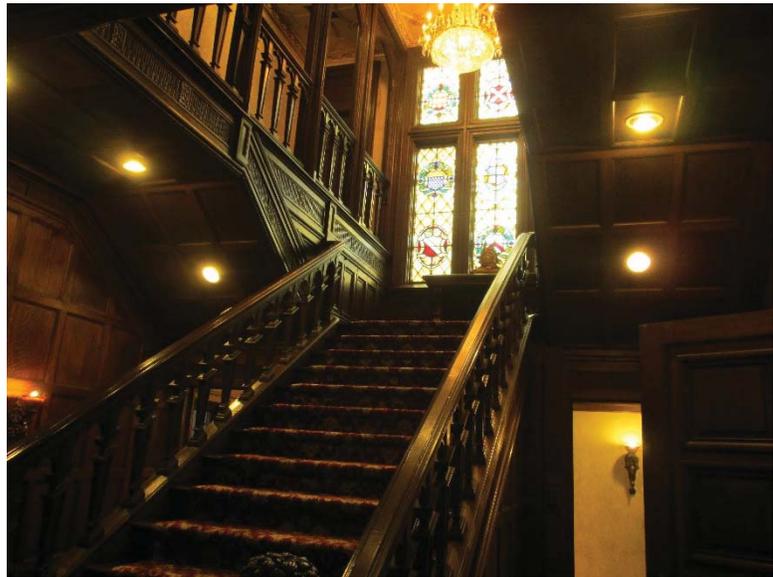
*Open Stair in Central Atrium*

There is a central stair which connects all three levels. It is unenclosed and creates an atrium affect connecting three levels. There are no fire barriers surrounding it, nor are fire sprinklers or a smoke pourge system provided. It does not meet current building code requirements.

interior wood framed partitions may be bearing and there may be some steel girders interspersed in the floor and roof structure. The construction classification would be considered Type 3B Construction, combustible unprotected, which complies with the height and area requirements outlined in the New Jersey Uniform Construction Code and International Building Code, 2015 New Jersey Edition. However, the existence of an unenclosed, unprotected three (3) story atrium with the main egress stair running through it, does not comply with current building codes.

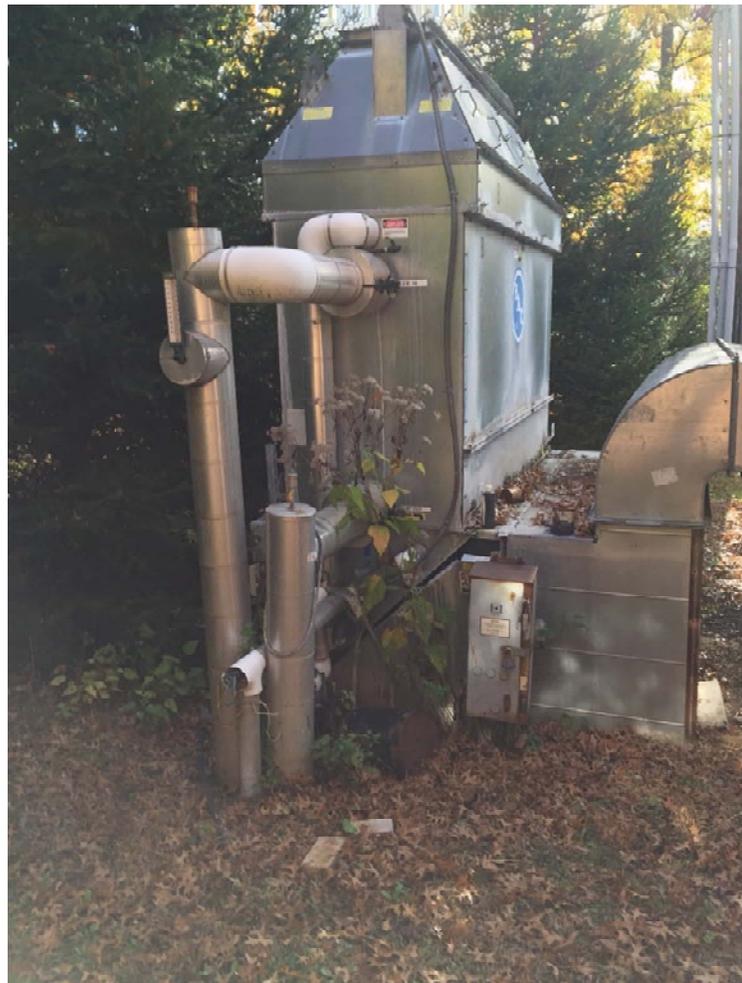
*Chiller Plant*

There is a 35 ton Baltimore Air Coil (BAC) Chiller located in the east yard of the building. The Model # is: VF102732KHX and based upon the Serial #U038655070, we estimate its age to be +/-50 years, We believe the chiller still functions, but it appears that maintenance on it has been neglected. The chiller provides air conditioning through a two (2) pipe, chilled water and chilled water return to connectors located through the building.

The convertors which distribute both hot and cold air from the heating, hot water system or cooling chilled system, range in appearance from fair condition to poor condition. A piped system is a superior system when maintained properly. However, we have concerns which include:

- The age of the systems and apparent lack of maintenance, may require destructive investigation to ascertain conditions and or perform the necessary maintenance.
- Due to the age of the chiller and boiler plants, we are concerned with their energy efficiency.
- A number of the convecter/ventilator covers are not in historically appropriate and should be replaced.
- Modification to the provide proepr zoning of the sytems within the existitng interior spaces will necessitate demolition of the historic finishes which should be restored to their original condition.

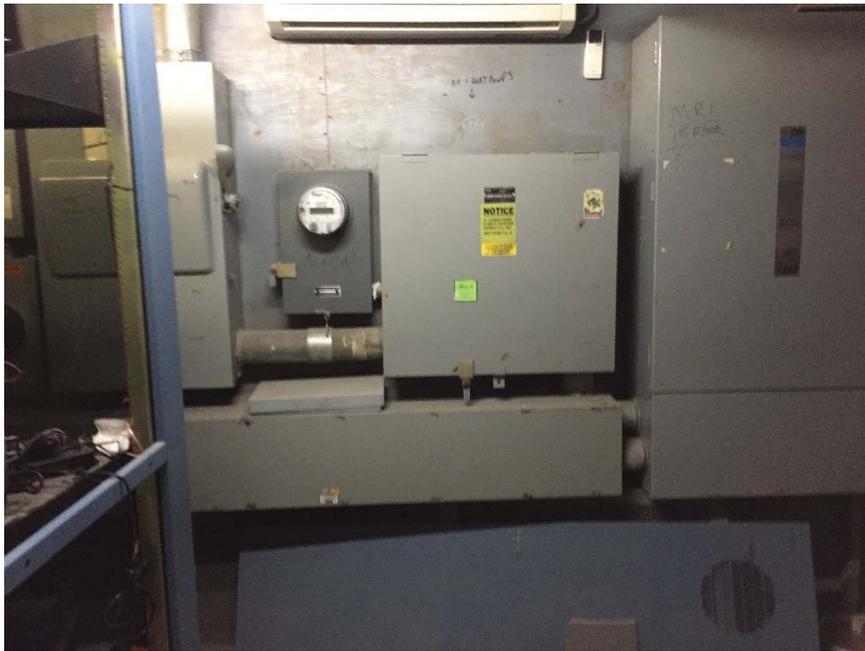
*Electric Service*

The building is fed by an electric service to a meter located in a utility room at the northwest corner of the basement. 1200 amp 240 volt switch is located in the same location; the manufacturer is ITE Gould. An ASCO 800 amp CT cabinet is located in the utility room and circuit panels which distribute power throughout. There are five (5) separate electric meters in the space as well.

Convenience outlets are located throughout the building. We observed a number of floor outlets on the first floor in the large “gallery” type space; many of the floor outlets were missing covers and stand proud of the finished floor creating a tripping hazard. The lighting is described under Section 3. It should be noted that none of the fixtures appear to be high efficiency type fixtures.
